# Property Inspection Report

**24 Hometown Ave.  
Anywhere, Ontario**

**Inspection Date:**  
November 22, 2008

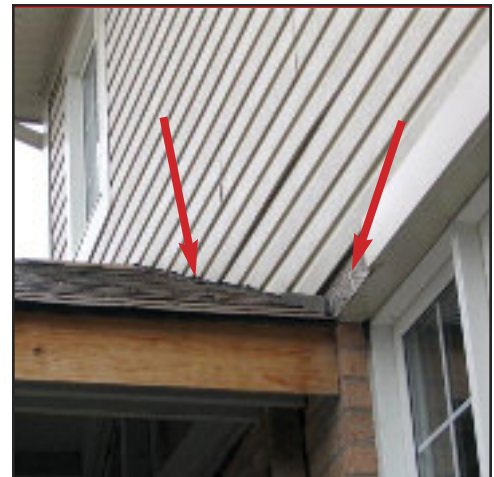
**Deficiency:** The flashing at the junction between the roof over the rear deck and the siding on the house has not been installed correctly, and may not be effective. Water may penetrate the wall, causing damage to the structure and interior finishes. There is also a short section of trim missing, exposing the waferboard sheathing, which is deteriorating.

**Course of action:** Either the owner or a roofing contractor should install flashings in a more effective manner and replace the missing trim as soon as possible to ensure that the exterior envelope of the building remains weather tight.

Install proper flashings on junction between rear deck roof and rear wall of house. Install missing trim piece beside deck roof.

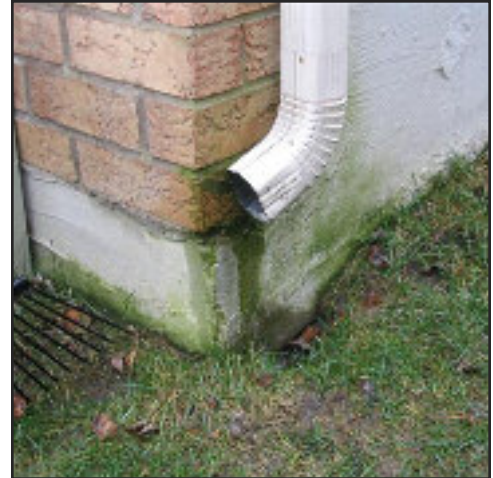
**Deficiency:** The gutter downspout at the north-west corner drains directly onto the ground beside the foundation wall. Water collecting against the building may lead to leakage into the basement, damage to the foundation wall, or erosion below the footings. There is already some erosion of the soil and evidence of leakage at this location.

**Course of Action:** A downspout extension should be installed to carry collected rainwater at least six feet away from the building.

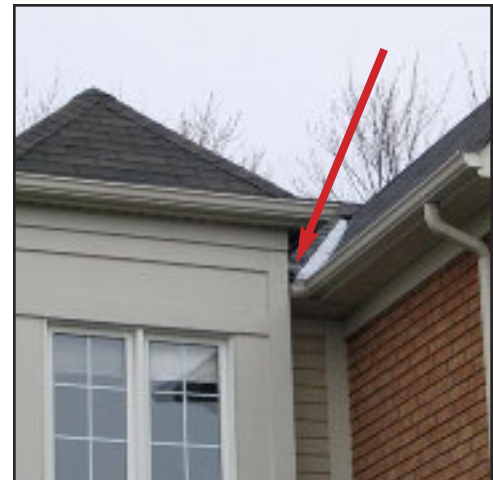
**Deficiency:** A valley between the south and west slopes of the roof drains into a very short section of gutter, which in turn slopes down against the siding on the guest room bathroom. Any significant rainfall will overshoot the gutter here and be directed against the siding, with the possibility of leakage into the wall. This could cause damage to the structure and interior finishes.

**Course of Action:** Have a roofing contractor investigate further. He may suggest installing a “kickout flashing”, or an effective alternative. Continue to monitor here and the area below, including the front porch roof, for any signs of leakage.

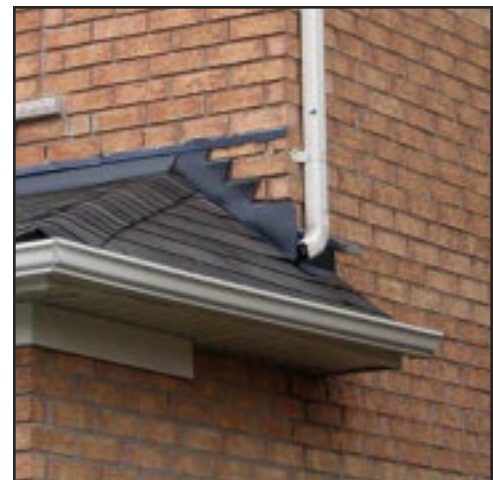
**Deficiency:** The downspout from the upper level roof gutter on the south-east corner drains directly onto the roof shingles over the garage. This arrangement can cause accelerated wear of the shingles. The elbow here also directs water behind the adjacent flashings. Water may get behind the flashings and damage the structure below.

**Course of Action:** Ideally, this downspout would be extended down this wall to ground level, where it would be carried away from the building by a downspout extension. An interim solution would be to redirect the elbow away from the flashings, and add an extension to carry the water directly to the gutter below. A downspout on the other side of the garage is arranged in a similar fashion. It too, should have an extension added to carry water directly into the gutter below.

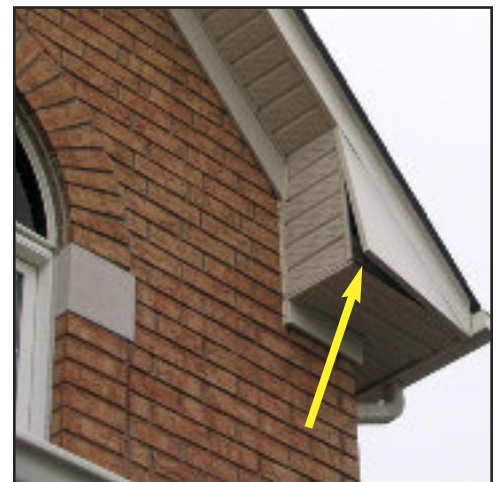
**Deficiency:** The metal trim panel over the garage roof has come loose. This could allow rain to penetrate and damage the structure here. This could also allow birds or bees to set up nest here. It is also common for squirrels to enter openings like this and cause considerable damage inside.

**Course of action:** Refasten this panel securely.

Securely fasten loose and open trim piece above garage roof.

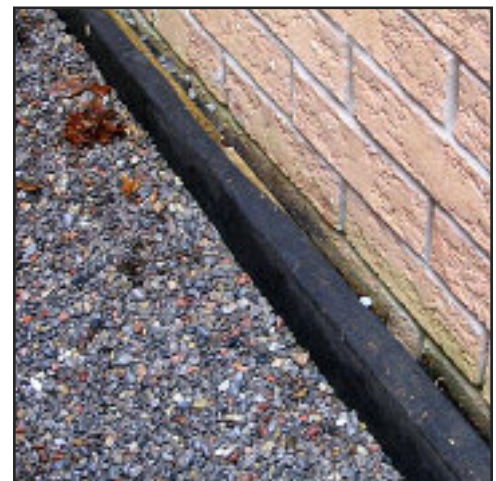
**Deficiency:** Some of the brick veneer siding on the east side of the house is below grade. The brick here will not dry properly, causing it to deterioration. Water penetration into the house at the top of the foundation wall, leading to damage to the structure and water in the basement, is also a possibility.

**Course of Action:** Alter the grading of the gravel in this area so that the brick is at least six inches above grade

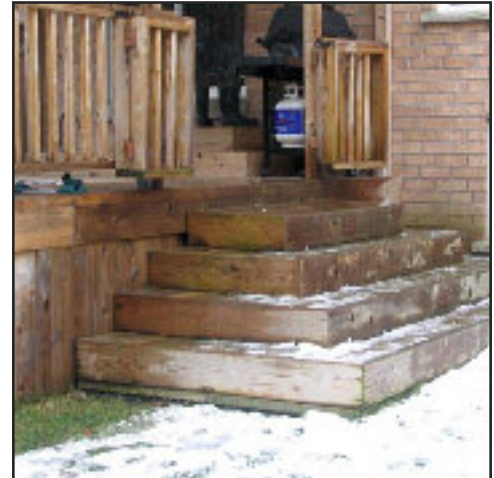
**Deficiency:** There are several issues with the deck on the back of the house:

The portion of railing between the deck and the fence is not secure, and is pulling the header joist away. This railing may not support the weight of someone leaning on it. This is a safety issue.

The stairs down to the ground lack the required handrailings. There is a trip and fall hazard here.

**Course of Action:** Re-secure the loose section of handrailing. Install handrails on the stairs down to the ground.

Re-secure the loose section of handrailing on the back deck. Apply a non-skid coating to the wooden ramp, or replace with stairs. Install handrails on the stairs down to the ground.

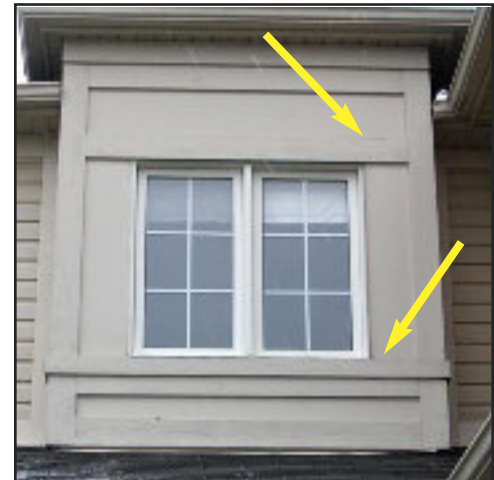
**Deficiency:** The siding on the guest bathroom is of a board and horizontal batten design. This type of finish is very vulnerable to peeling paint, water penetration and rot, especially the horizontal surfaces. Water leakage here could also result in damage to the structure and interior surfaces. The paint in several areas is already beginning to peel.

**Course of Action:** This area should be monitored and maintained carefully. All the joints between boards should be caulked to prevent water intrusion. The wooden finial which decorates the adjacent roof peak should also be painted to prevent rot.

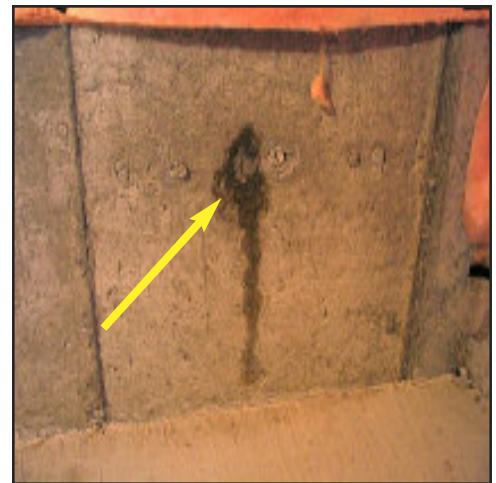
**Deficiency:** On the day of the inspection there was slight leakage at the north-west corner of the basement. There were also stains on the wall here, which would indicate previous leakage. This appeared at one of the "tie rod" holes, which are holes spaced along the poured concrete walls, left by the steel rods which held the forms together. They are normally filled with concrete, but remain more porous than the rest of the wall. If this leakage continues, items stored in the basement might be damaged.

There was another small crack in the central area of the east foundation wall with a water stain, but no apparent moisture.

**Course of action:** This leak was very close to the missing downspout extension outside the house. Replacing the downspout to direct water away from the building should stop the leakage, but continue to monitor these areas.

Monitor leak in basement to be sure that the cause was effectively eliminated.
