Controlling the Hazard and Liability of Asbestos in Vermiculite Insulation

Warnings for the Homeowner, Building Manager, Contractor and Real Estate Industry

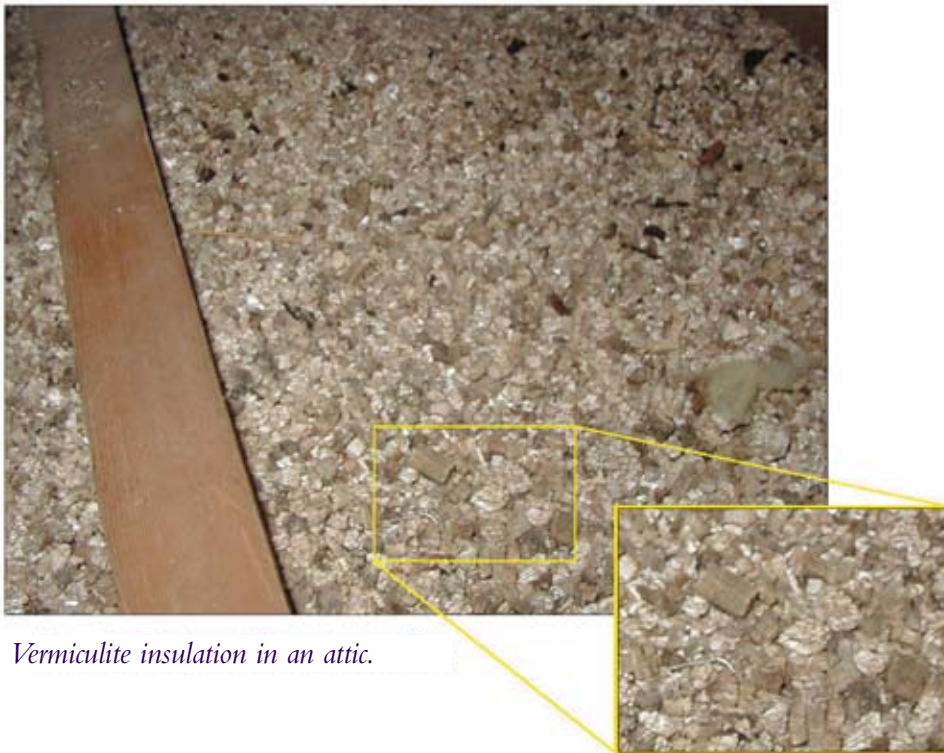
Vermiculite insulation in an attic.

Vermiculite insulation in loose form can be readily visually identified as a light weight, silvery grey or blonde, granular, layered material, with particle sizes of about 2 to 10 millimeters. If vermiculite is known to have been installed prior to 1990 visual identification should be adequate to confirm the material as asbestos-suspect.

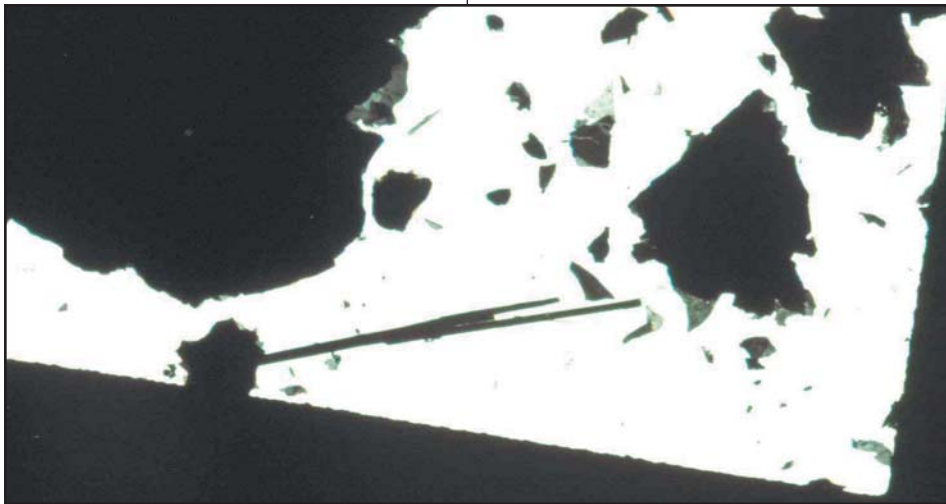
Asbestos in vermiculite attic insulation (TEM, 880X)
